Manhole Inspection Summary

Manhole # S35AA_017MH

Inspection Is Incomplete Rating: **3) Fair**

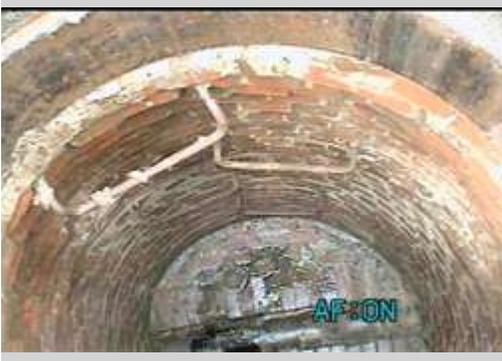
Defect 2

Steps Count: **4** Missing: **0** **Corroded**

corr steps

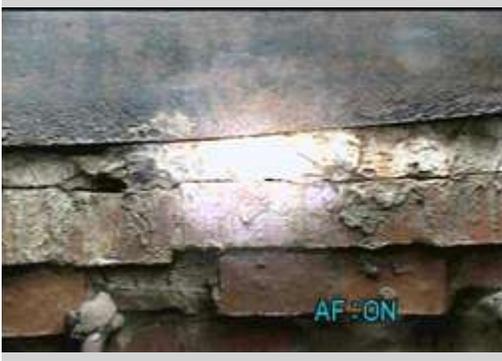
Defect 1

Condition: Sound **Cracked** Root Intrusion Loose Brick Deteriorated

cracked frame

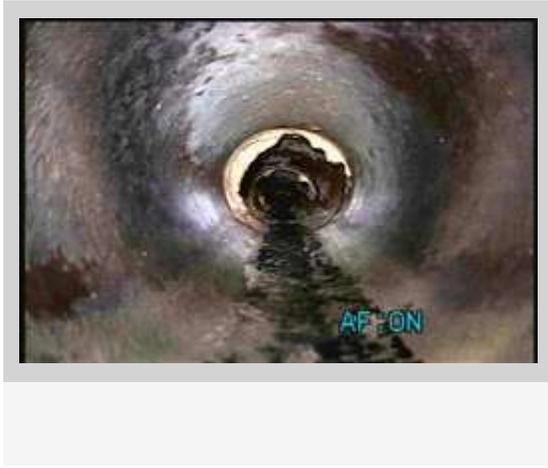
12 O'Clock Outflow

6 in. Circular Gravity Sewer
Pipe Out @ 12 O'Clock

Pipe Height: **0** (in.) Direct
Pipe Material: **Unknown** Pipe Lined
Invert Depth: **8.60** (ft.) Flow Characteristics: **Slow**
Deposits: None Mud Sludge Debris Grease
Silt Depth: **0** (in.) Deposits Extent:
Infiltration: **None** Pipe Seal Cond: **Unknown**

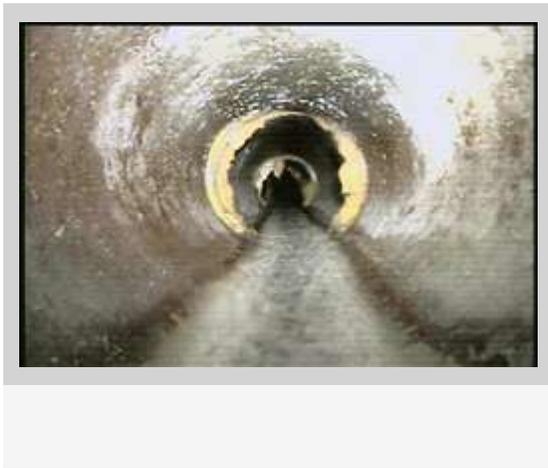
6 O'Clock Inflow

6 in. Circular Gravity Sewer
Pipe In @ 6 O'Clock

Pipe Height: **0** (in.) Direct
Pipe Material: **Clay** Pipe Lined
Invert Depth: **8.40** (ft.) Flow Characteristics: **Slow**
Deposits: None Mud Sludge Debris Grease
Silt Depth: **0** (in.) Deposits Extent:
Infiltration: **None** Pipe Seal Cond: **Unknown**

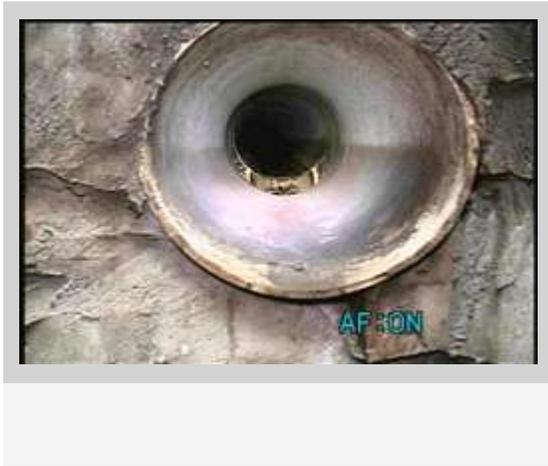
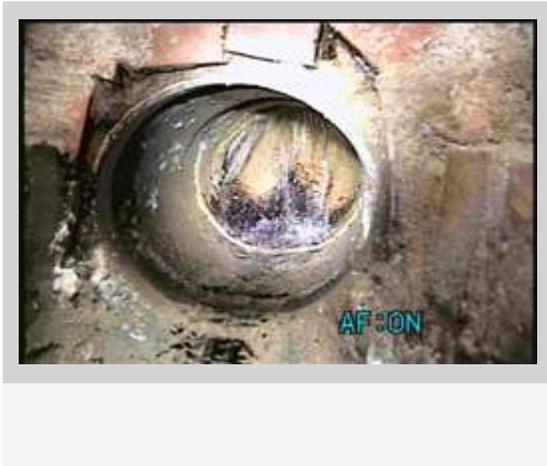
9 O'Clock Inflow

6 in. Circular Gravity Sewer
Pipe In @ 9 O'Clock

Drop In @ 9 O'Clock

Drop: Outside Direct
Angled: Reading: 0.00 (ft.)
Inv Depth: 8.00 (ft.)
Drop Condition: Open
